Inspection & Repair Report

**Goulds 18 HMO Pump
Hot Well Supply Pump
APR Job 04172
November 30, 2004**

APR **ACCURATE
PUMP
REPAIR, INC.**

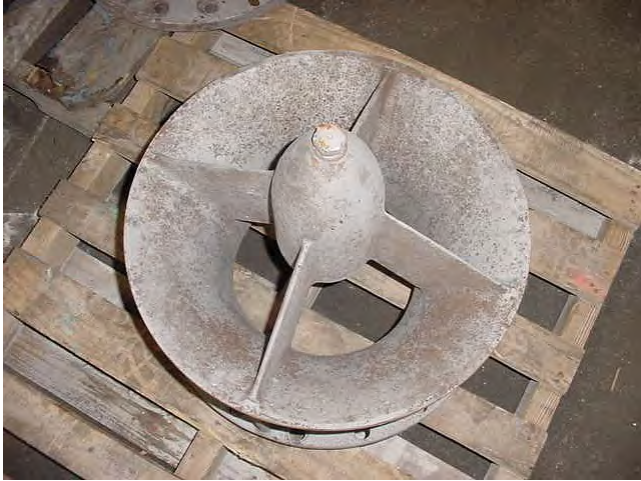
Suction bell

The suction bell is severely damaged from cavitation.

Supply a new suction bell.

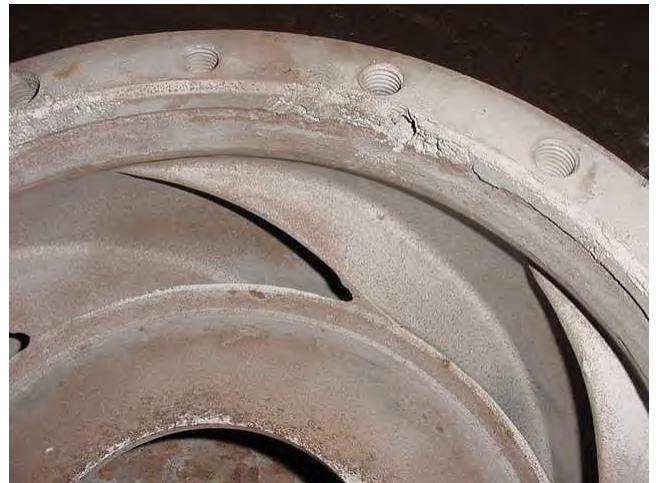
Bowl register damage

The bottom bowl register is damaged from the cavitation in the suction bell.

Weld and machine the eroded area of the bowl register.

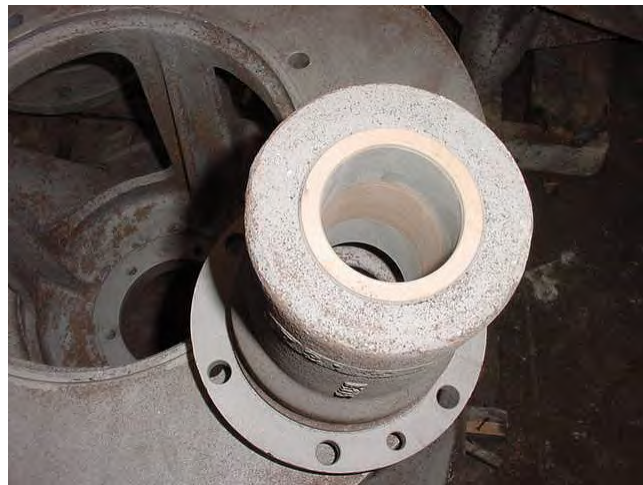
Packing box bearing

- The discharge head is in good condition.
- The discharge head registers are within design tolerance.
- The packing box is in good condition.
- The packing box register is within design tolerance.
- The packing box bearing is evenly worn.
- The ceramic head shaft journals are pitted and scored.
- The head shaft threads are damaged from set screws.
- Set screws in threaded couplings are not recommended.

Supply a new nitronic 60 packing box bearing.

The bronze PTF coated packing box bearing was replaced with a nitronic 60 bearing.

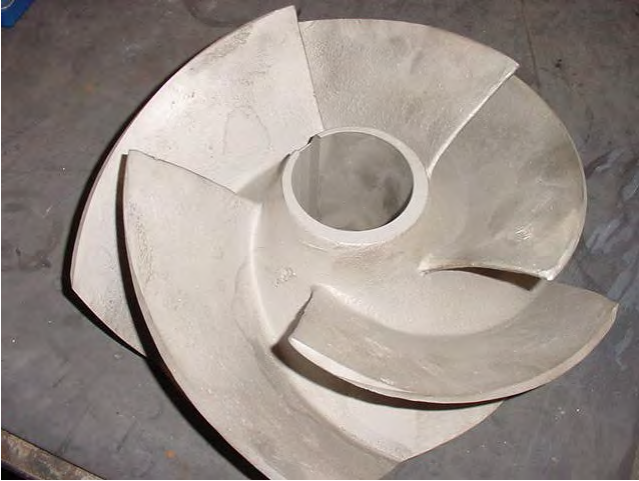
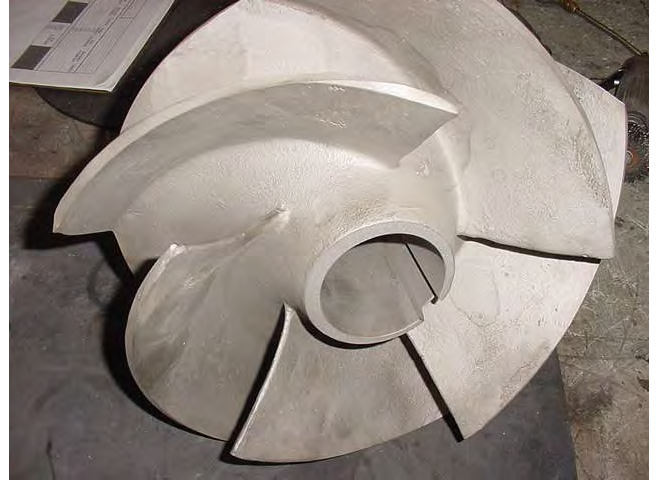
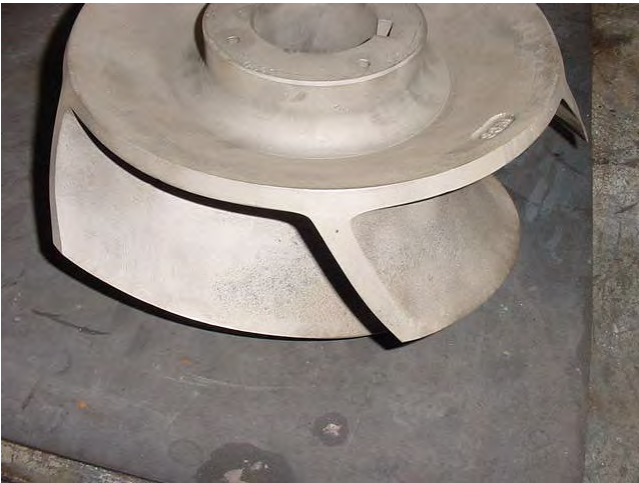
The impeller is in good condition.

The impeller bore is within design tolerance.

The impeller vanes are not back filed.

Back file the impeller vanes.

Dynamically balance the impeller.

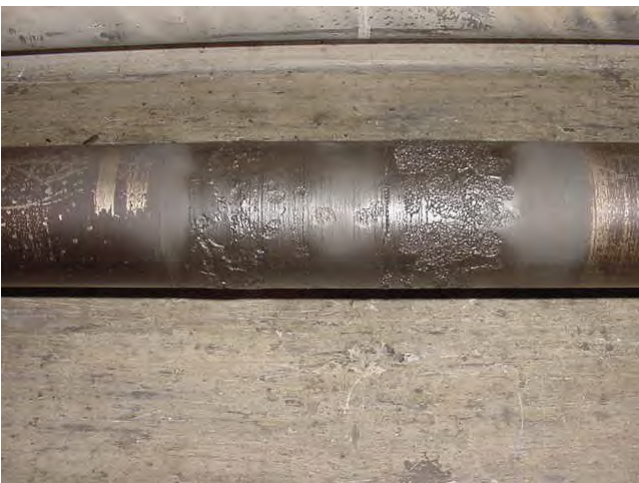
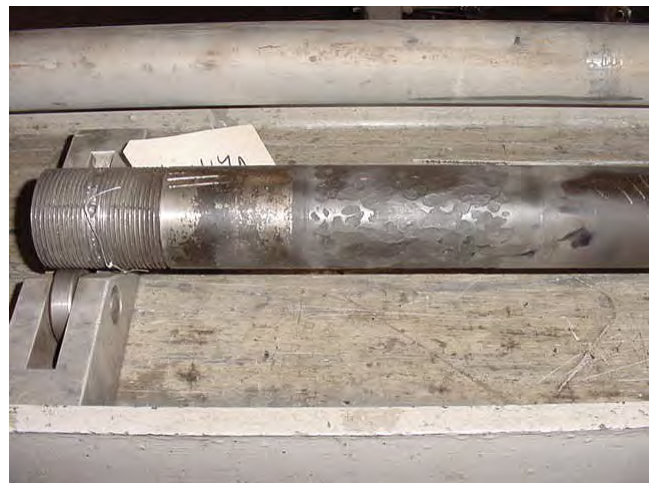
Pump shaft journal

The ceramic journals on the pump shaft are pitted and scored.

Remove the old coating from the pump shaft journals.

Coat the journals with Tungsten / Chrome / Cobalt.

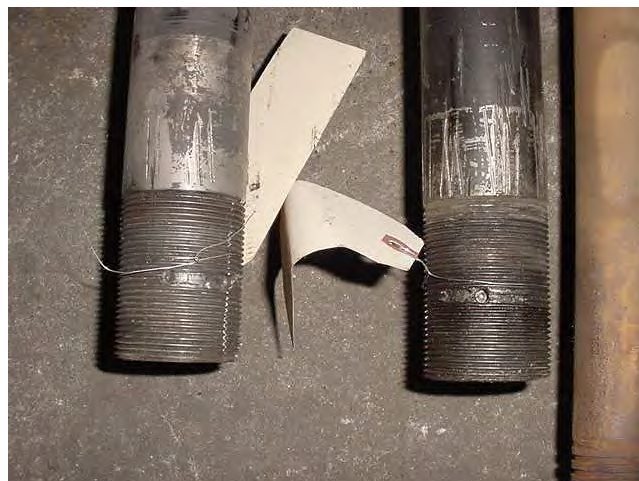
Damaged shaft threads

- The column pipes are in good condition.
 - The bearing retainers are in good condition.
 - The column and retainer registers are within design tolerances.
 - The ceramic line shaft journals are pitted and scored.
 - The line shaft threads are damaged from set screws.
 - The rubber line shaft bearings are lightly worn.
-

Supply a new head shaft.

Supply a new line shaft.
