Inspection & Repair Report

**Goulds 18 HMO Pump
Hot Well Supply Pump
APR Job 04172
November 30, 2004**

APR **ACCURATE
PUMP
REPAIR, INC.**

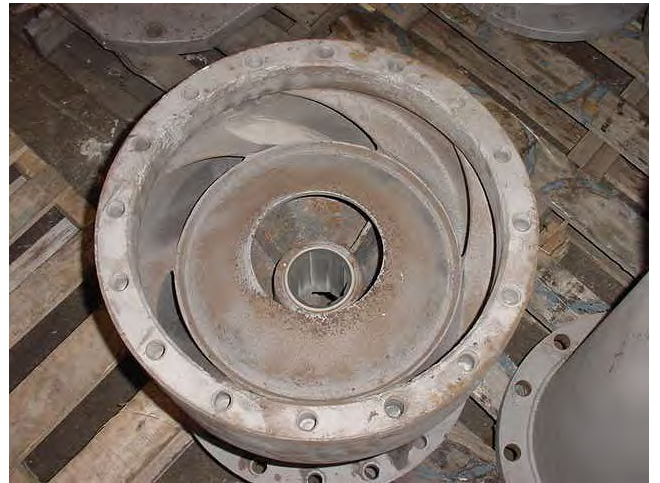
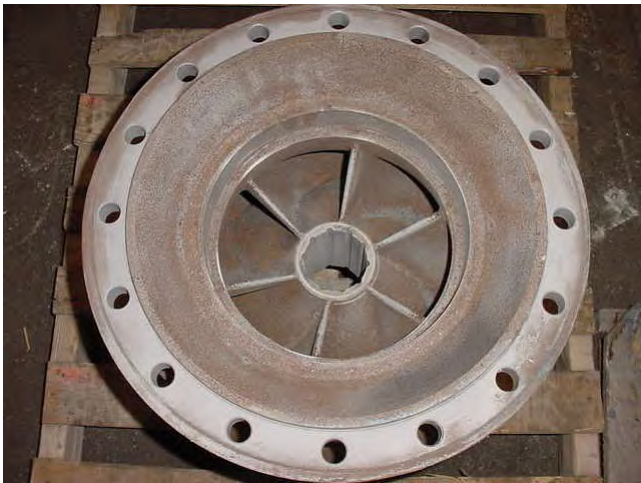
Bowl

The bottom bowl register is damaged from the cavitation in the suction bell.

Weld and machine the eroded area of the bowl register.

Coat the bowl assembly OD with a two-part epoxy.

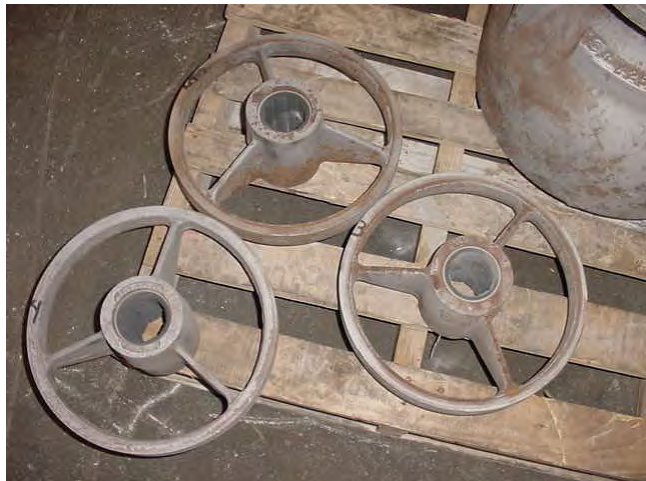
Retainers

- The column pipes are in good condition.
 - The bearing retainers are in good condition.
 - The column and retainer registers are within design tolerances.
 - The ceramic line shaft journals are pitted and scored.
 - The line shaft threads are damaged from set screws.
 - The rubber line shaft bearings are lightly worn.
-

Supply 3 new rubber retainer bearings.

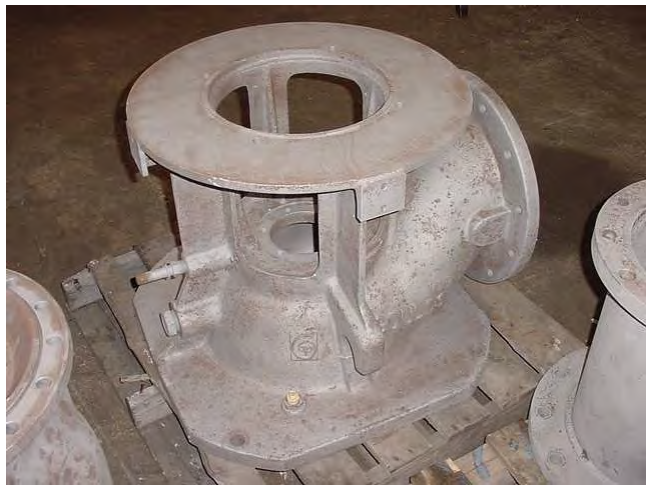
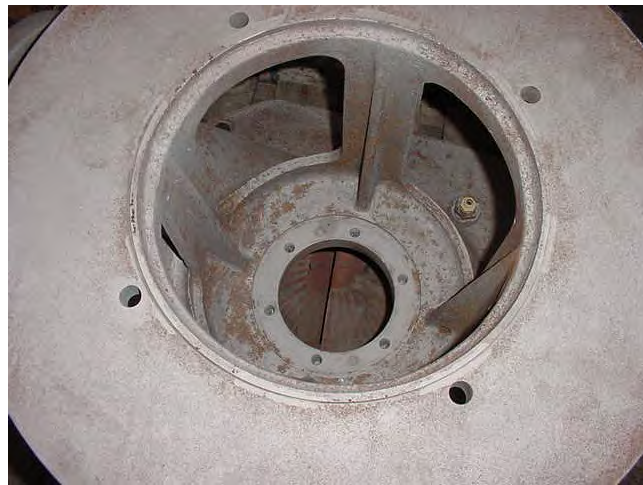
Discharge head

- The discharge head is in good condition.
- The discharge head registers are within design tolerance.
- The packing box is in good condition.
- The packing box register is within design tolerance.
- The packing box bearing is evenly worn.
- The ceramic head shaft journals are pitted and scored.
- The head shaft threads are damaged from set screws.
- Set screws in threaded couplings are not recommended.

Coat the ID and OD of the discharge head with a two-part epoxy.

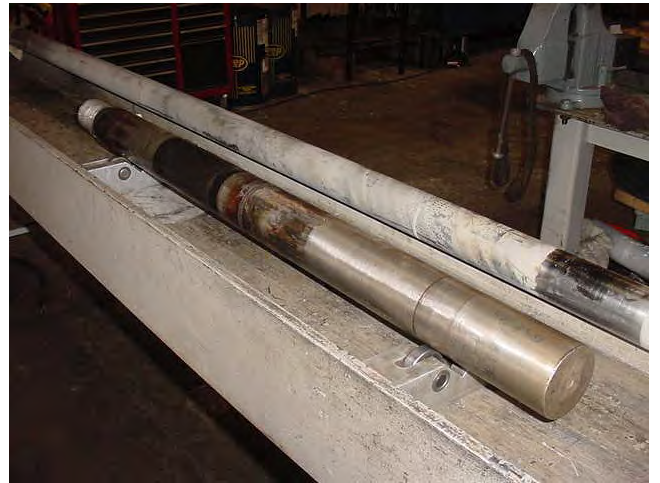
Pump shaft

The ceramic journals on the pump shaft are pitted and scored.

Remove the old coating from the pump shaft journals.

Coat the journals with Tungsten / Chrome / Cobalt.
